Characteristics of hydrodynamic plain bearings with bonded coating

Björn Prase¹, Erhard Leidich²

Chemnitz University of Technology, Department of Engineering Design

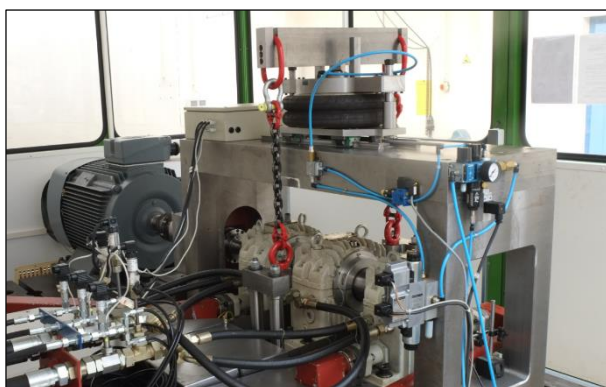
All tests were performed on the hydrodynamic plain test bench (GL 110) (Figure 1a). Depending on the planetary gear used, speeds of up to 100 m/s are possible. The maximum load is 50 kN. The rotor has a diameter of 110 mm. Figure 1b shows schematically the loading device with force directions, direction of rotation and the segmentation of the bearing.

Figure 1: a) Test benches; b) Schematic structure of the loading device with segmentation

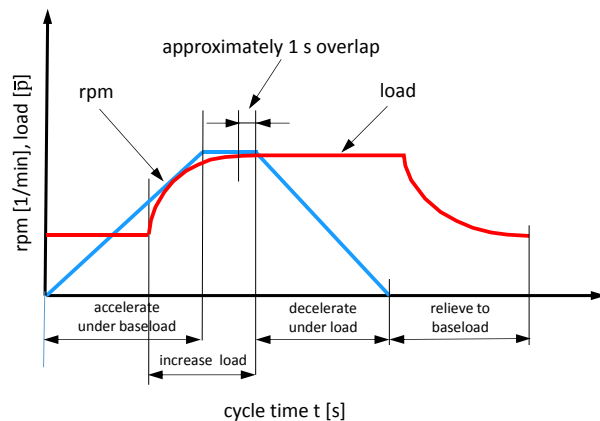
Figure 2 shows the profile of a start-stop cycle. The shaft was accelerated under a specific bearing load of 1 MPa to a rated speed of 900 rpm. After reaching the rated speed, the specific bearing load increased to 2 MPa or 4 MPa, respectively. Finally, the shaft was decelerated (under load). A test block comprised 10,000 load cycles. The flow rate was 25 l/min.

Figure 2: Schematic representation of a start-stop cycle

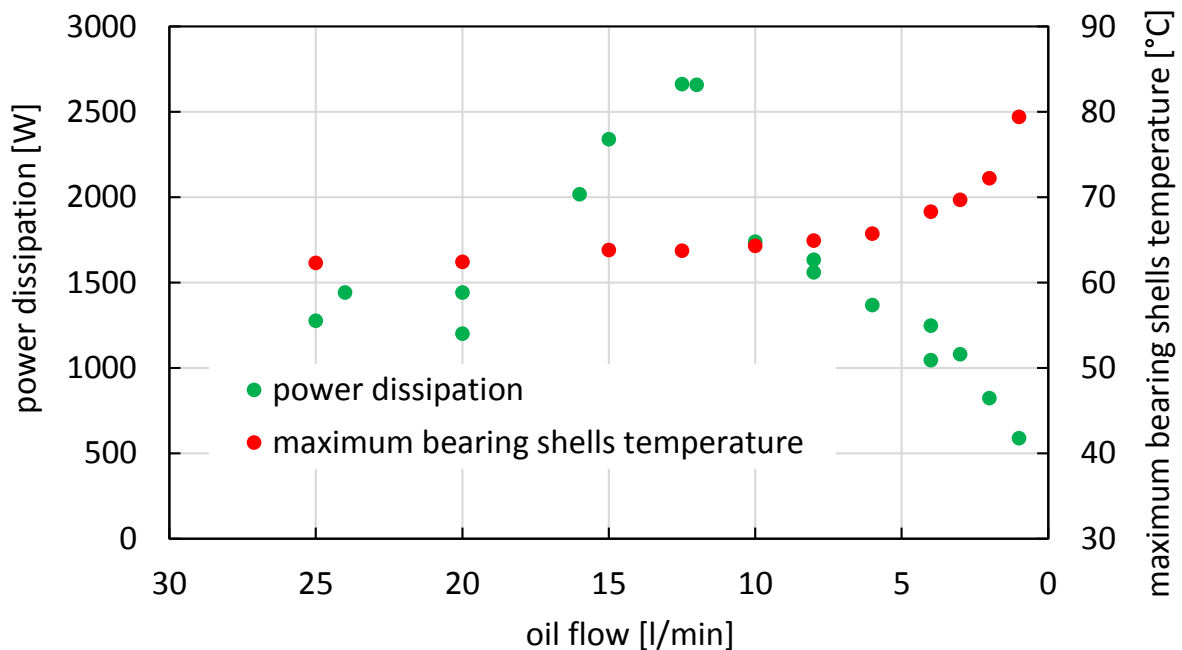
Testing with a stepwise reduction of the oil supply was performed exclusively on the plastic-coated bearing (figure 6). Previous studies have shown that, with inadequate lubrication, the bearings with white metal alloy fail very fast.

Figure 6: Power dissipation and bearing shell temperature plotted against oil flow

As expected, the bearing shell temperature increased with the reduced oil flow. The oil flow was reduced to 1 l/min (technical limit of the oil supply system). In the configuration used, the bearings showed a significant increase in power dissipation at 12.5 l/min. This may be due to turbulent behaviour. The tests have shown that a reduction in the power loss of up to 75% is possible.

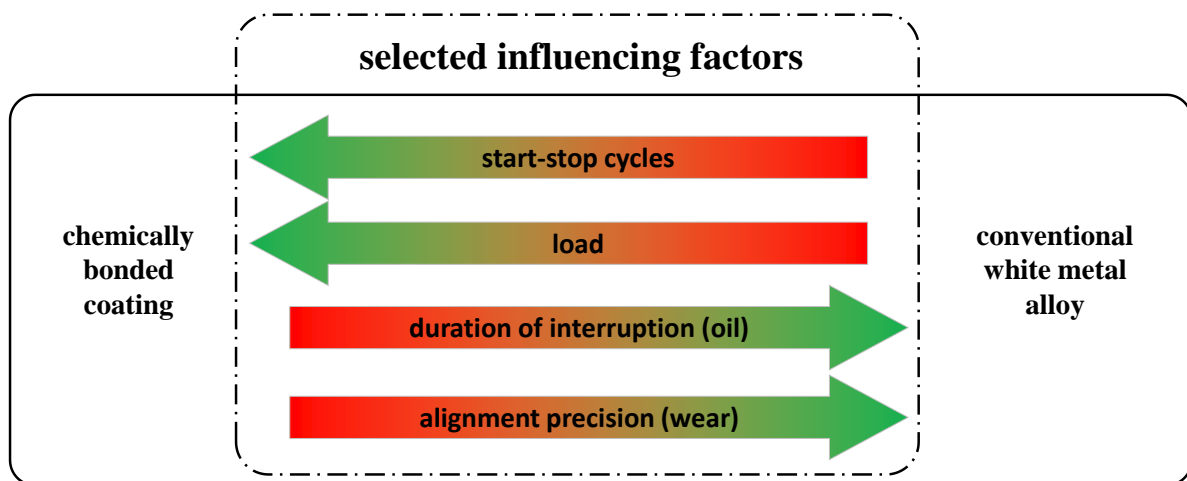
A general statement as to which is the best wear layer is not possible. This would require a differentiated consideration of the application. Figure 7 attempts to explain selected influencing factors based on selected applications.

Figure 7: Criteria for an application taking selected influencing factors as an example

As the start-stop testing showed, the chemically bonded coating has a significantly higher load limit and exhibited no significant wear. The bearing would be ideal for the automotive sector, for use in start-stop engines, so that wear could be reduced and the service life could be extended. The problem relates to the damage incurred: during longer dry running, the bearing system seizes (no wear). The extremely sharp braking associated with this can cause considerable damage to the whole system. The coating is therefore only of limited use for large systems.
